MARYLAND HISTORICAL TRUST

INVENTORY FORM FOR STATE HISTORIC SITES SURVEY

MAGI# 03/5/54611 1 NAME BR-1466 BA-1165 B**a-1**66 HISTORIC MAGI-0314664811 MAGI-0314654611 MAGI-0314644611 Kaufmann's Pharmacy, Smrcina's Dry Cleaning, Wilson's Electric AND/OR COMMON Residence Chesapeake Barber Shop **2** LOCATION STREET & NUMBER 401, 405-407, & 409 York Rd.; 4 West Chesapeake Ave. CITY, TOWN CONGRESSIONAL DISTRICT Towson, Maryland VICINITY OF Baltimore County COUNTY 3 CLASSIFICATION **CATEGORY** OWNERSHIP TOT STATUS **PRESENT USE** _DISTRICT ___PUBLIC __AGRICULTURE **X**PRIVATE XBUILDING(S) _UNOCCUPIED X_COMMERCIAL __STRUCTURE () __вотн __WORK IN PROGRESS *PRIVATE RESIDENCE __EDUCATIONAL __SITE **PUBLIC ACQUISITION** ACCESSIBLE __ENTERTAINMENT __RELIGIOUS __OBJECT _IN PROCESS XYES: RESTRICTED __GOVERNMENT _SCIENTIFIC __BEING CONSIDERED **__YES: UNRESTRICTED** __INDUSTRIAL __TRANSPORTATION __MILITARY _OTHER: **OWNER OF PROPERTY** Louise F. Hergenrather PLUS see titles Telephone #: STREET & NUMBER 7906 Knollwood Road 一人。居以汉汉之。 \$2.1900 Maryland, 21204 CITY, TOWN TOWSON ____ VICINITY OF S LOCATION OF LEGAL DESCRIPTION Liber #: WJR No.3479 COURTHOUSE Folio #: 472 REGISTRY OF DEEDS, ETC. Balti

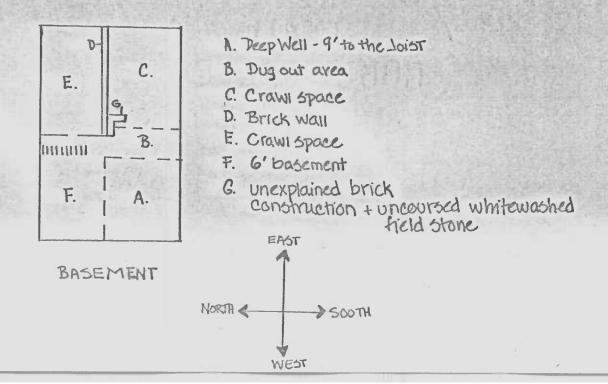
The basement is an unusual one for Towson. It has a stone foundation ond circular sawn floor joists. However, since there appear to be several different phases involved, the best way to correctly see this would be to follow the diagram below. This basement is especially interesting because of a reference to a stone house on this site in a deed dated July 28, 1874, in Liber JB 88 folio 112, in a transaction from Janine Hamilton to Samuel Robinson. It is possibly the same house located on "Mrs. Hamilton's Lot", in the enclosed 1877 Atlas of Baltimore County, Maryland.
